NAVAL AVIATION SAFETY CENTER

146982

NARRATIVE BRIEF

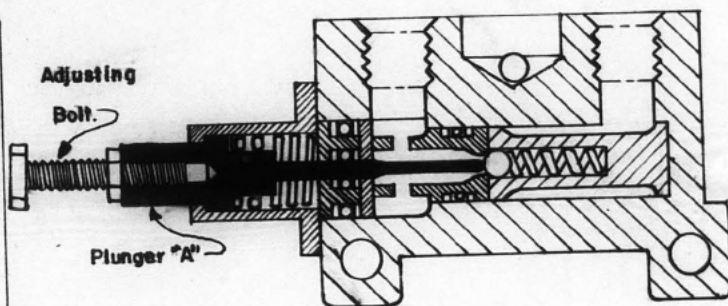
(Encl. 10)

WING SPREAD SEQUENCE VALVE

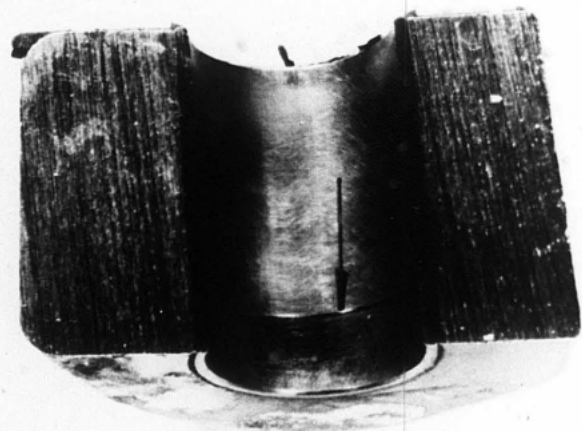
ENCLOSURE (1)

UNDUE LOADS ON THE TWO OUTER PANEL LUGS, WHICH WERE ENGAGED. ENCLOSURES (1) AND (2) INDICATE THE POSITION OF PINS IN THE SECOND LUG FROM THE REAR OF EACH INBOARD FITTING. THERE WAS NO INDICATION OF RUBBING OR MISALIGNMENT TO THE FRONT OR REAR FACES OF THE REMAINING LUGS STILL ATTACHED TO THE OUTER WING PANEL. THE WEAR OF THE OUTER PANEL HINGE FITTING BUSHINGS WAS NOT BELIEVED TO LIMIT THE HINGE LOCKING PINS FROM FULLY EXTENDING. THE WEAR PATTERN IN THE BUSHING LUGS, AS SHOWN IN ENCLOSURES (1) AND (2), WAS APPARENTLY FROM THE LOCKING PINS EXTENDING TO THESE POINTS AND THEN THE WHOLE FITTING BEING SUBJECTED TO VIBRATORY AS WELL AS FLIGHT LOADS.

AFT HINGE FITTING

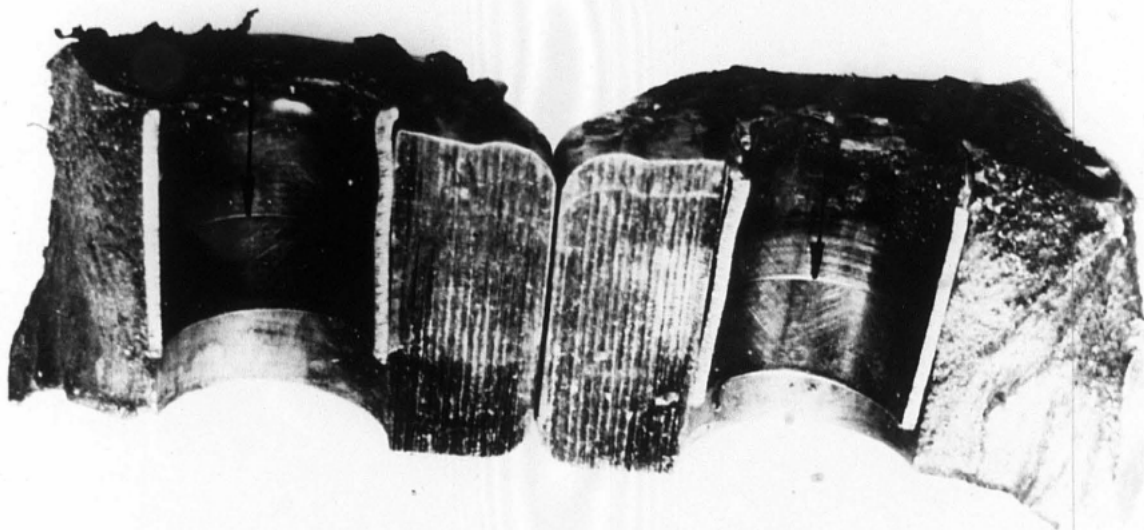
ENCLOSURE (2)

FWD HINGE FITTING

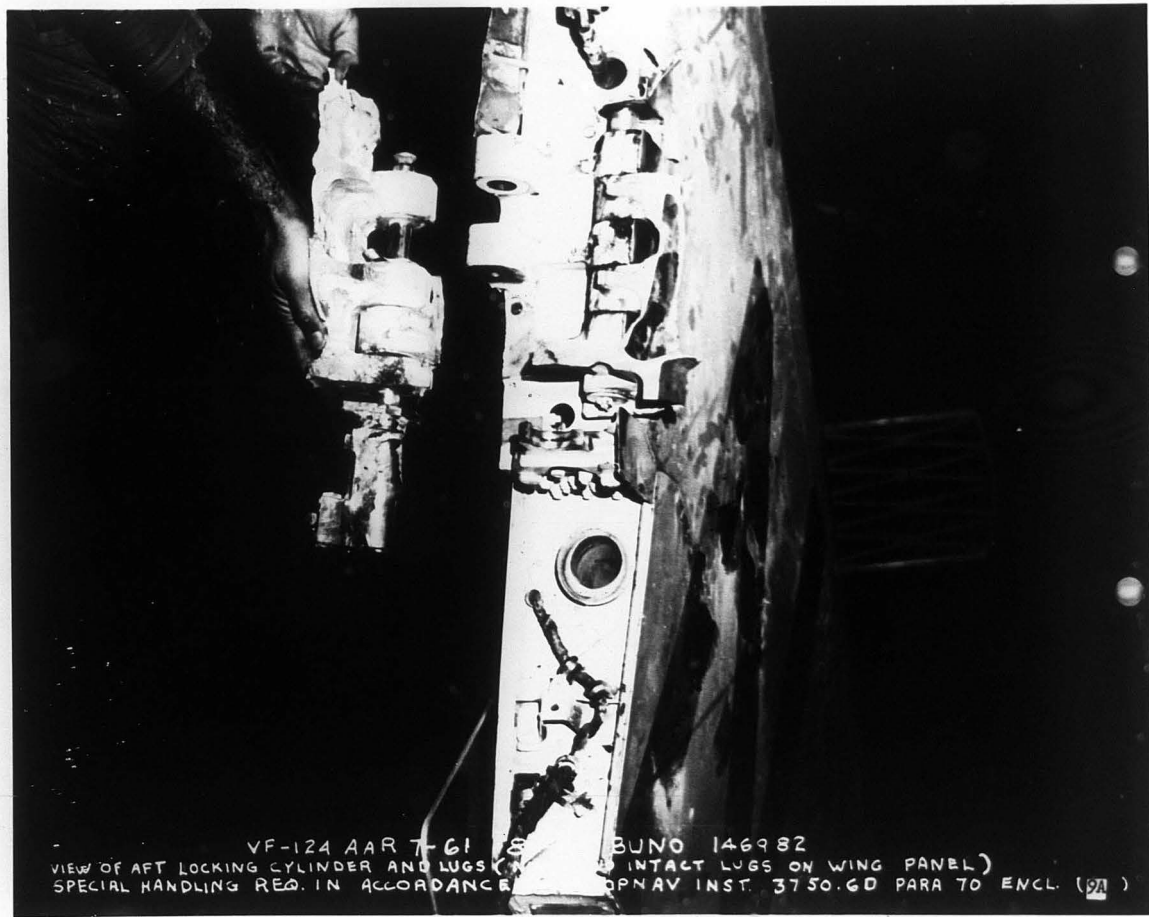
VF-124 AAR 7-61 18 BUNO 146982
VIEW OF AFT LOCKING CYLINDER AND LUGS (WING PANEL) (INTACT LUGS ON WING PANEL)
SPECIAL HANDLING REQ. IN ACCORDANCE WITH OPNAV INST. 3750.6D PARA 70 ENCL. (97)

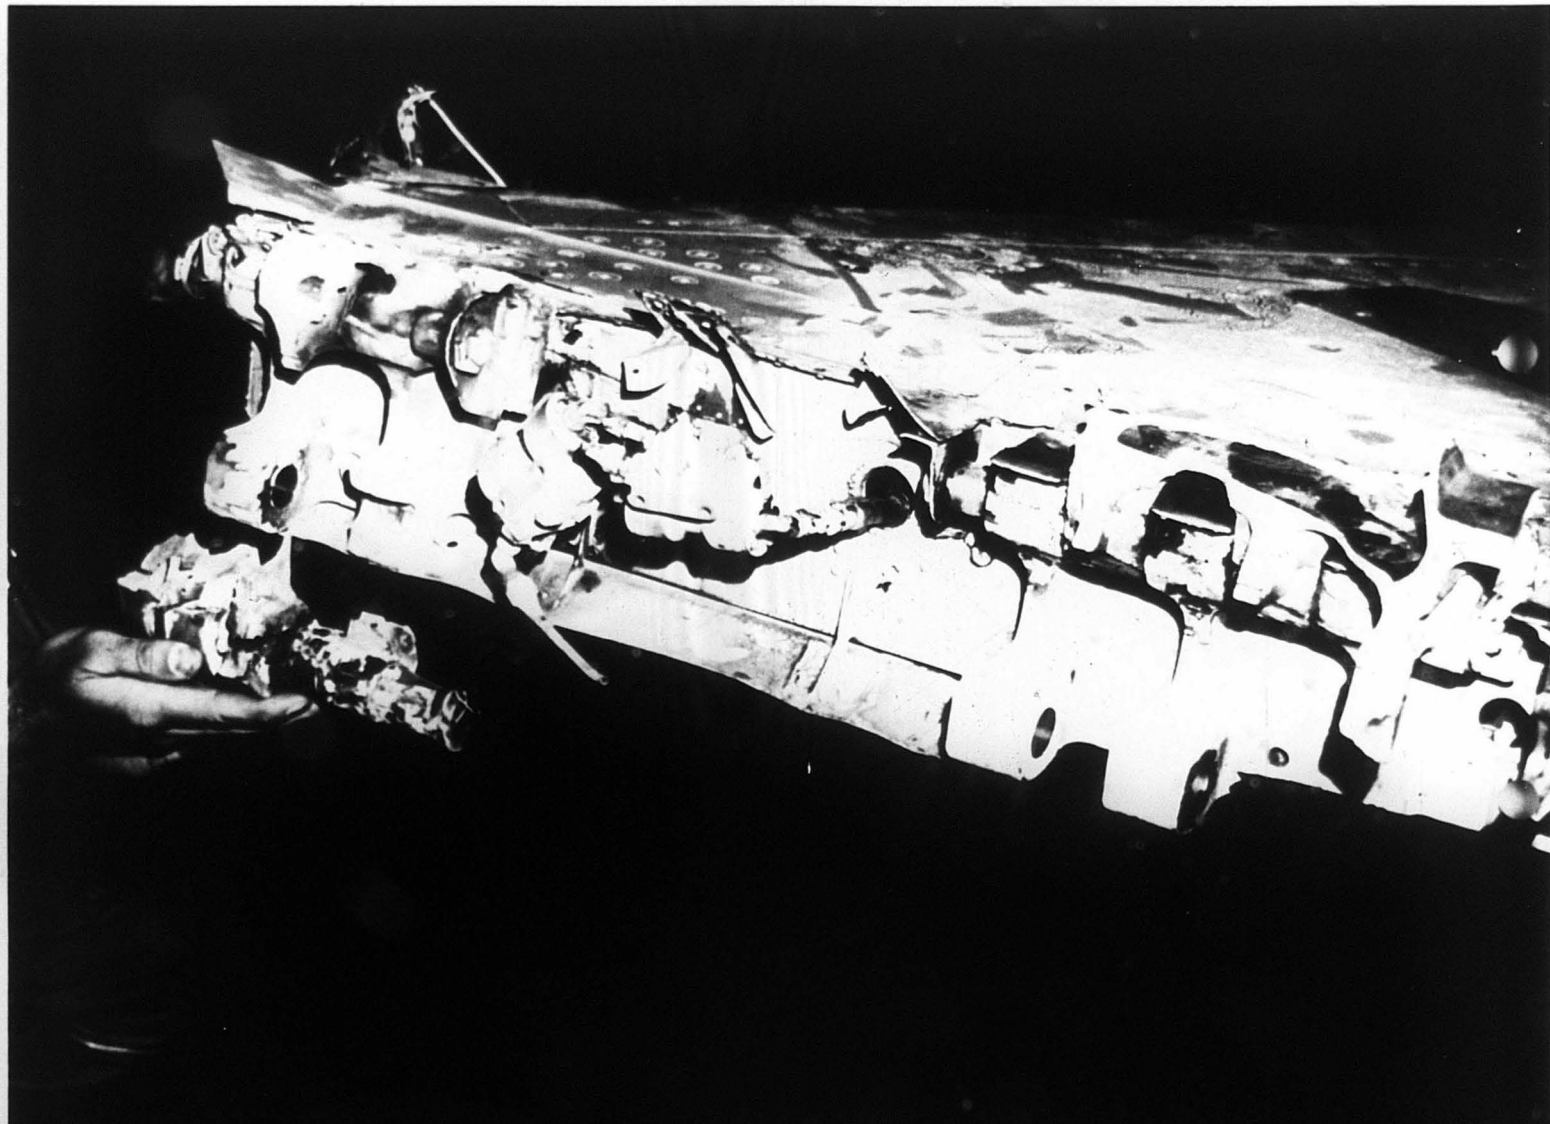
B. FORWARD AND AFT, RIGHT WING, HINGE PIN CYLINDERS, P/N CV15-901021-008 AND P/N CV15-901030-010. BOTH WING HINGE PIN CYLINDERS WERE RECOVERED FROM THE AREA OF GROUND IMPACT OF THE AIRCRAFT. THE PINS WERE FOUND EXTENDED SUFFICIENTLY TO BE THROUGH ALL OF THE INBOARD LUGS FROM BOTH FITTINGS. THE LUGS SHEARED FROM BOTH THE FORE AND AFT FITTINGS WERE FOUND TO BE POSITIONED BETWEEN THE PROPER LUGS FROM THE INBOARD FITTINGS. IMPACT WITH THE GROUND AND RESULTING JOSTLING OF THE DEBRIS SUBJECTED THE PINS TO A FORWARD MOMENTUM, THEREBY PENETRATING THE REMAINING LUGS. THE LUGS WERE REMOVED FROM THE LOCKING PINS AND THE SECOND LUG FROM EACH OF THE INBOARD FITTINGS CUT IN HALF.

VF-124 AAR 7-61 F8U-2 BUNO 146982
VIEW OF 'FWD' LOCKING CYLINDER AND LUGS (NOTE ONE LUG IS STILL INTACT)
SPECIAL HANDLING REQ. IN ACCORDANCE WITH OPNAV INST. 3750.60 PARA 70 ENCL. (9B)

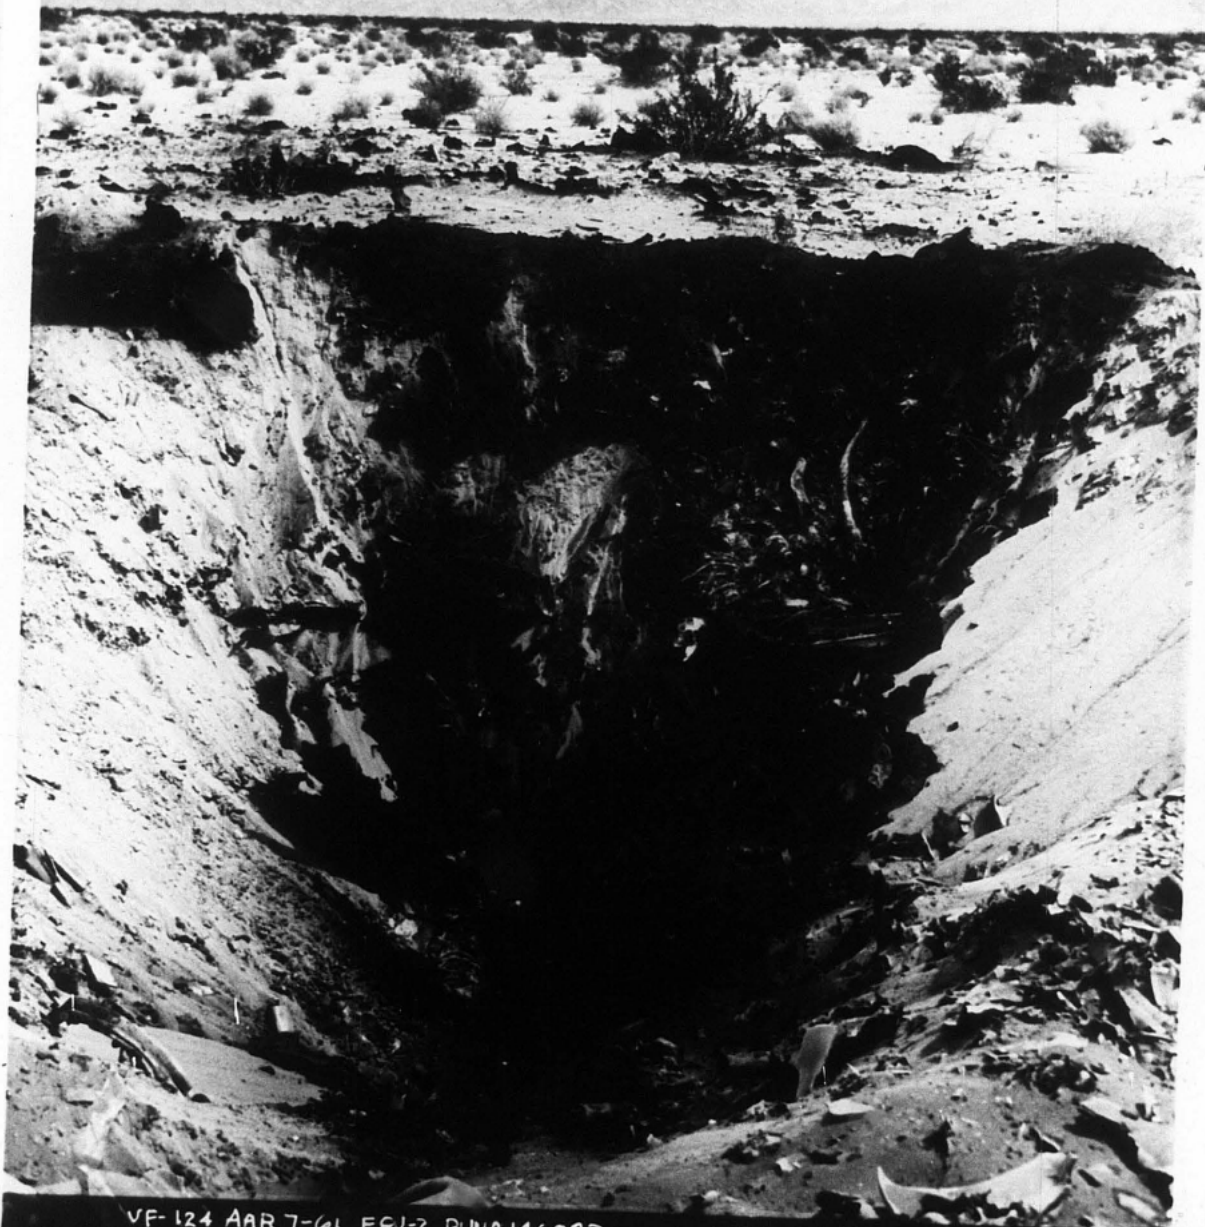
After the pilot ejected at 20,000 feet, the aircraft assumed a vertical right corkscrew motion and struck the ground in a near vertical attitude. The aircraft exploded upon impact and sustained strike damage. See enclosures 8A through 8D for view of impact area and location of larger pieces of wreckage.

VF-124 AAR 7-61 FSJ-2 BUN0146982 VIEW LOOKING NW
SPECIAL HANDLING REQ. IN ACCORDANCE WITH OPNAV INST. 3750.60
PAAA 70 ENCLOSURE (8B)

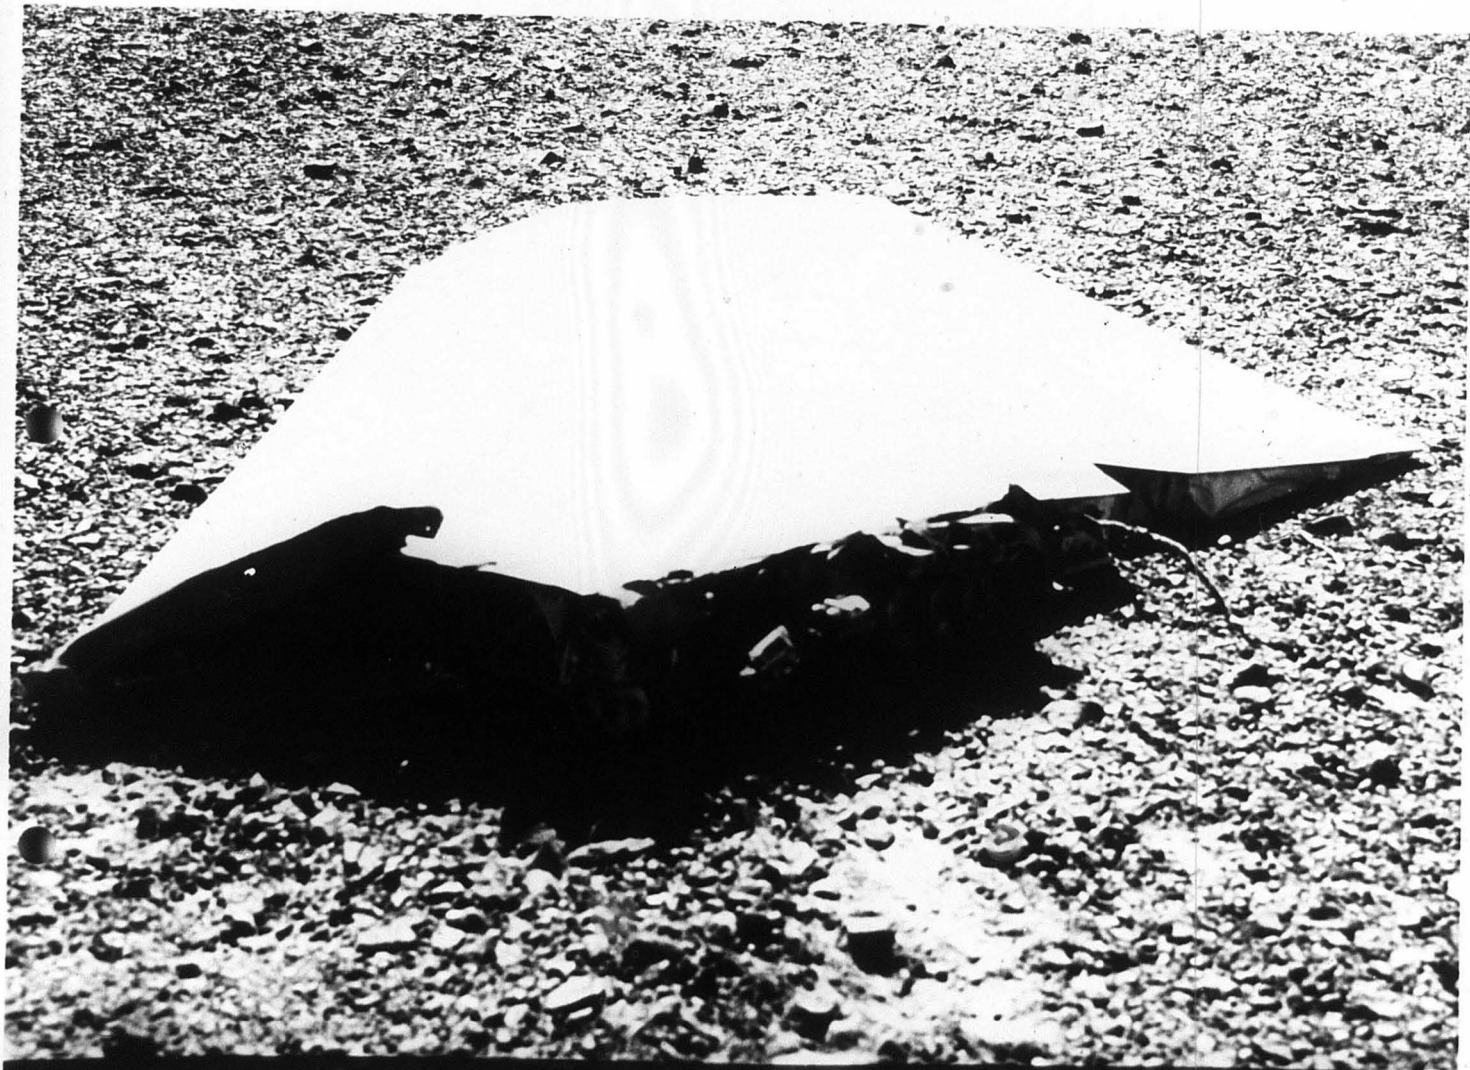
The entire starboard outer wing panel, including the outer panel leading edge droop, was broken off at the wingfold area while the aircraft was in a gunnery run at 20,000 feet. Sometime during the vertical violently rolling dive the starboard center section leading edge droop tore away from the aircraft, rolled under the wing and inflicted an arc of scratches and breaks in the starboard fuselage skin in the area just below the wing leading edge. When the center section droop went under the wing it hit and carried away the starboard ventral fin. Utility hydraulic pressure was reduced to 500 pounds during the uncontrolled flight and shortly after recovery dropped to zero.

VF-124 AAR 7-61 F8U-2 BUNO 146982
VIEW OF WING PANEL AS FOUND ON GUNNERY RANGE
SPECIAL HANDLING REQ. IN ACCORDANCE WITH OPNAV INST. 3759.6D PARA 7D ENCL. (8D)

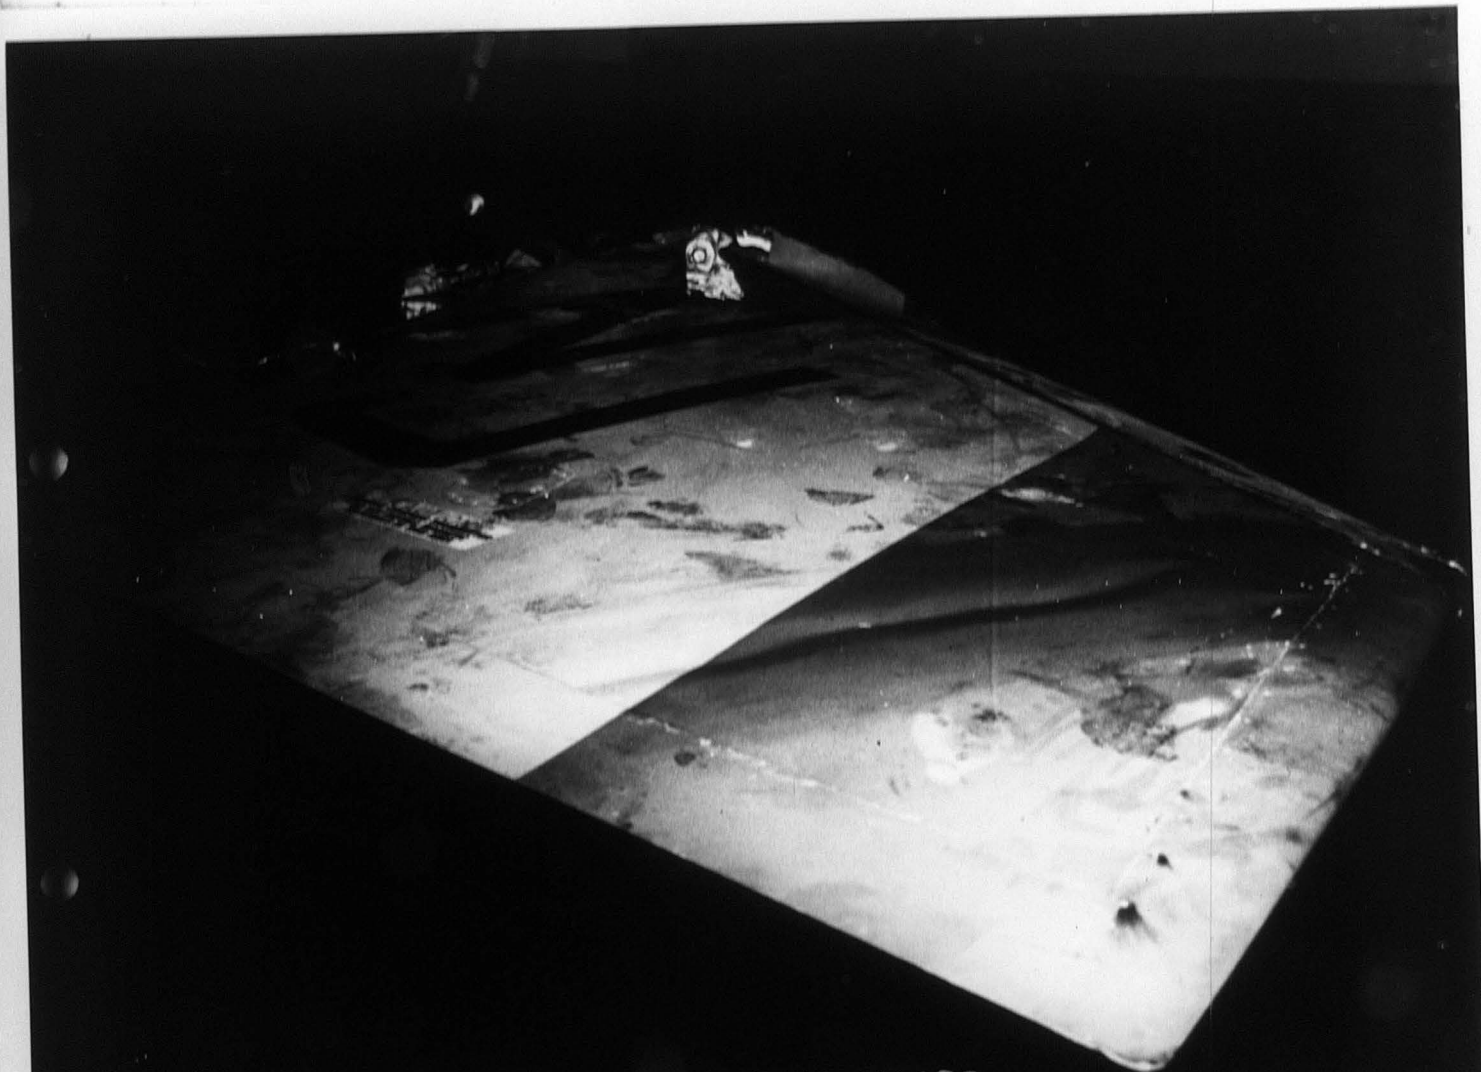
A. THE COMPRESSIVE BUCKLE IN THE UPPER SURFACE OF THE WING OUTER PANEL IS BELIEVED TO HAVE RESULTED DURING GROUND IMPACT. IT IS FURTHER BELIEVED THAT FAILURE OF THE WING OUTER PANEL ATTACHING STRUCTURE RESULTED FROM FAILURE OF THE WING HINGE LOCKING PINS TO ENGAGE ALL OF THE LUGS, THUS PLACING

VF-124 AAR 7-61 FBU-2 BUNO 146982
VIEW OF BUCKLE TO TOPSIDE OF STARBOARD WING PANEL
SPECIAL HANDLING REQ IN ACCORDANCE WITH OPNAV INST 3750.6D PARA 70 ENCL. (8E)
